# Parts and Material Analysis Report

## Summary

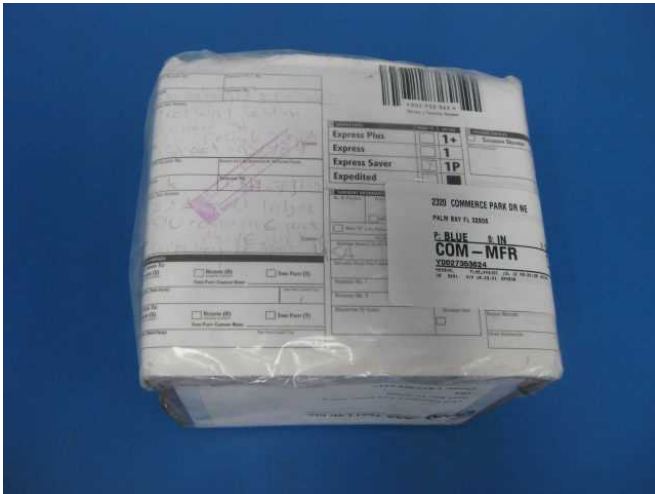
Criteria	Result	Comments
<b>Receiving - Documentation and Package Inspection</b>		
Lot/Date Code information consistent with published data	C	
Manufacturer label/logo are present and matches datasheet and prev orders	C	
Documentation review	C	
Barcode data scans and matches	NA	
Consistent package materials	C	
<b>General Visual Inspection</b>		
Parts received in a single shipment	C	
Consistent part markings throughout lot	C	
Consistent appearance	C	
Consistent handling, packaging and storage	C	
No evidence parts have been separated	C	
Box received in acceptable condition. Devices were received in acceptable condition. Part markings were consistent throughout the samples inspected and did match customer order information.

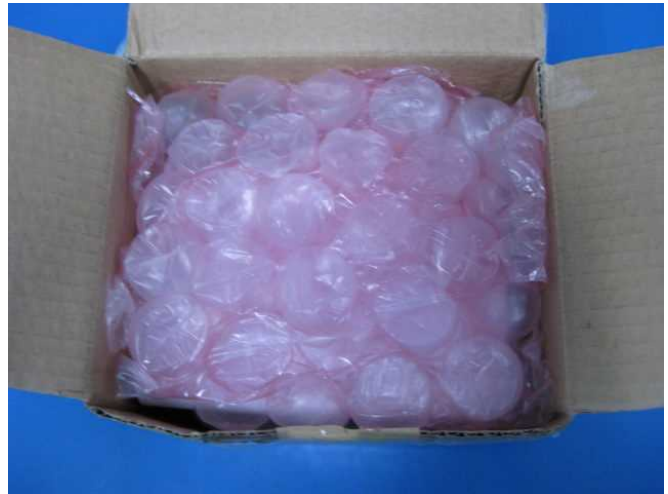
**Package Condition**

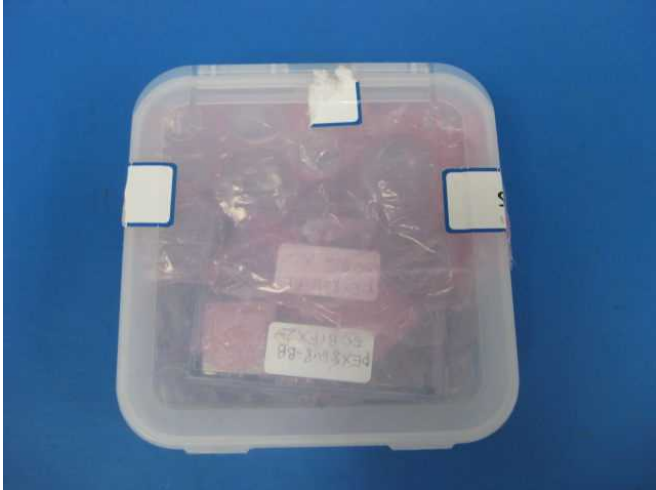
## Receiving Inspection ( Continued )

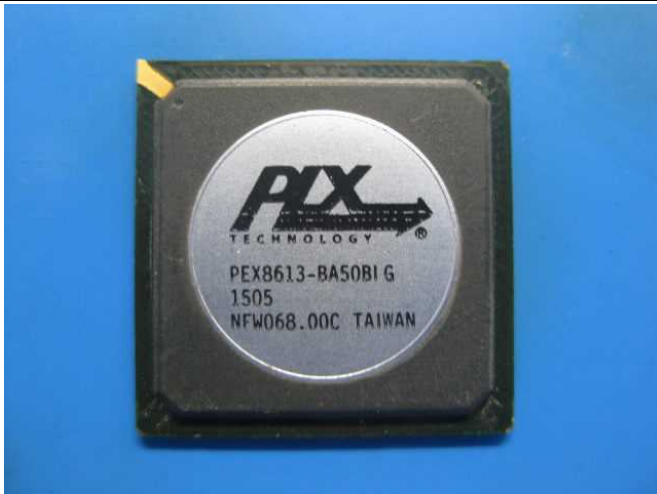
**NOTE:** All inspections in this section performed in accordance with TS Test Procedure Manual, 622-001, Sections 1-3; microscope magnification = 10X to 30X unless otherwise noted.

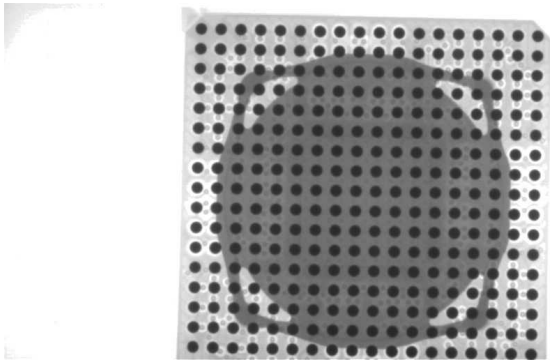
**X-Ray Analysis - Sample 1**

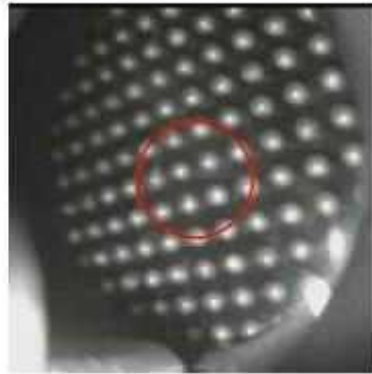
ppm	#	Error
Cd	< LOD	:	446.369
Pb	25429.895	#	1087.519
V	30074.707	#	3895.783
Cr	< LOD	:	2941.619
Mn	1774.087	#	884.326
Fe	< LOD	:	825.624
Co	< LOD	:	528.886
Ni	< LOD	:	803.459
Cu	584054.125	#	4347.006
Zn	< LOD	:	1008.846
Se	420.590	#	145.992
Br	123.727	#	46.674
Zr	< LOD	:	149.853
Nb	< LOD	:	211.061
Mo	< LOD	:	316.989
Pd	< LOD	:	97.486
Aq	13931.646	#	426.177
Al	< LOD	:	800000.000
In	< LOD	:	320.257
Sn	210322.938	#	3037.189
Sb	< LOD	:	342.643
Ba	15996.746	#	841.507
W	< LOD	:	2.000
Pt	< LOD	:	845.341
Au	< LOD	:	644.901
Hg	< LOD	:	380.079
Tl	115684.547	#	6827.620
Bi	< LOD	:	460.478

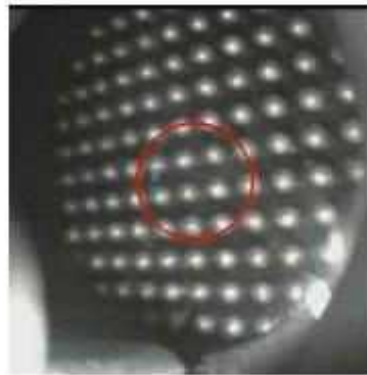
ppm	#	Error
Cd	< LOD	:	293.568
Pb	26288.801	#	1082.657
V	29743.000	#	3827.678
Cr	< LOD	:	2843.168
Mn	< LOD	:	1712.735
Fe	< LOD	:	795.535
Co	< LOD	:	544.359
Ni	< LOD	:	829.471
Cu	577271.063	#	4278.825
Zn	< LOD	:	966.403
Se	402.030	#	143.407
Br	< LOD	:	98.744
Zr	< LOD	:	141.421
Nb	< LOD	:	203.859
Mo	< LOD	:	315.551
Pd	< LOD	:	99.916
Aq	19907.537	#	516.302
Al	< LOD	:	800000.000
In	< LOD	:	311.258
Sn	203922.703	#	2925.829
Sb	< LOD	:	345.772
Ba	13801.529	#	800.102
W	< LOD	:	2.000
Pt	< LOD	:	858.251
Au	< LOD	:	568.085
Hg	< LOD	:	472.463
Tl	125219.094	#	6760.089
Bi	< LOD	:	502.915
